Quality bulletin LT3

49T77-07460

MITSUBISHI TURBOCHARGER

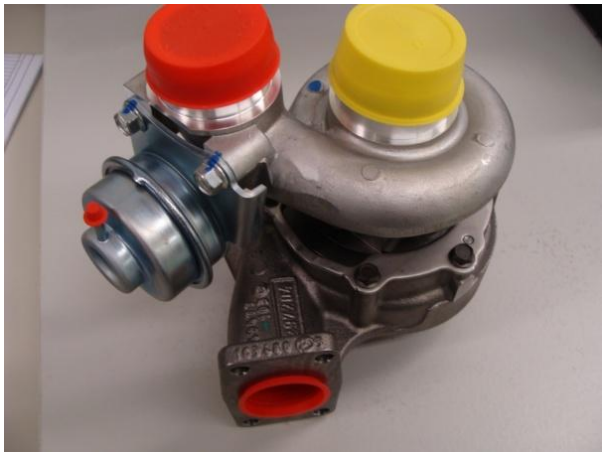
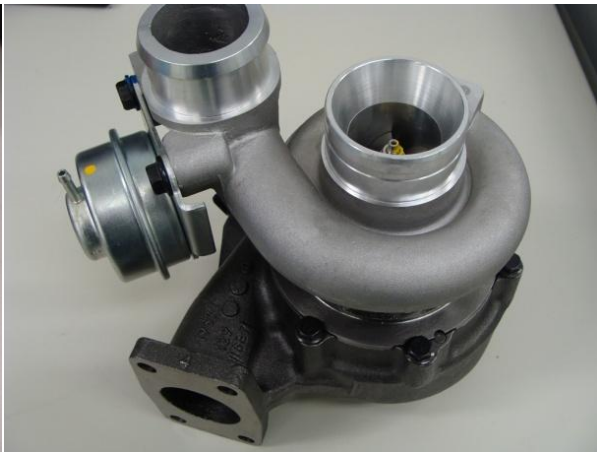
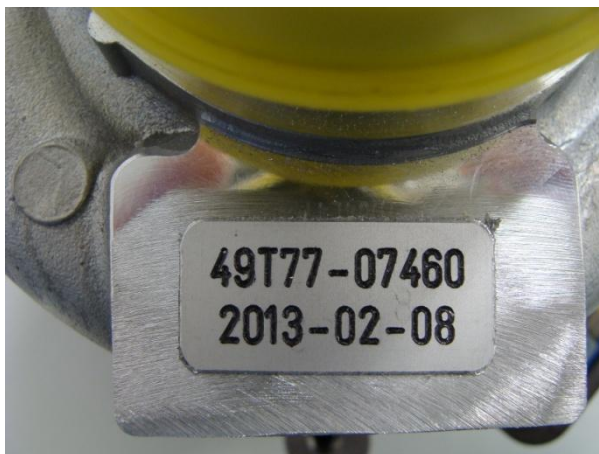
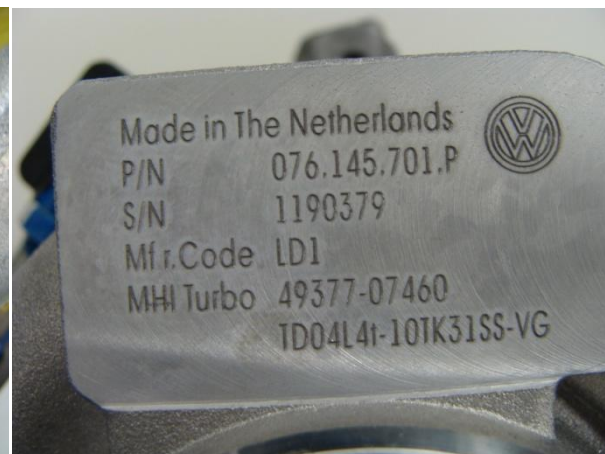
In our continuous search for improvement of our products and after sales, we would like to help you with the battle against counterfeit sales. That's why we want to keep you informed of the dangers that fitting a counterfeit can produce when a garage fits it on a customer's car. That's why we have tested a counterfeit LT3 turbo against one of our own OE quality product. We have inspected it thoroughly, tested it and now want to share all our findings with you. We have found the following differences; on the left you can find the original MHI part:

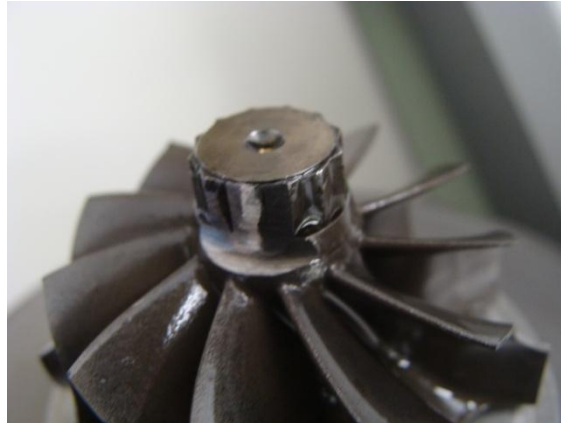
All rotors that are produced by MHI are balanced fully automatic and is grinded in one motion by a CNC robot. The rotor of the counterfeit is balanced by hand and as seen on the picture it has not been done correctly in one grind. These multiple grinds are not only bad looking but balancing is a product of trial and error instead of knowledge and technology.

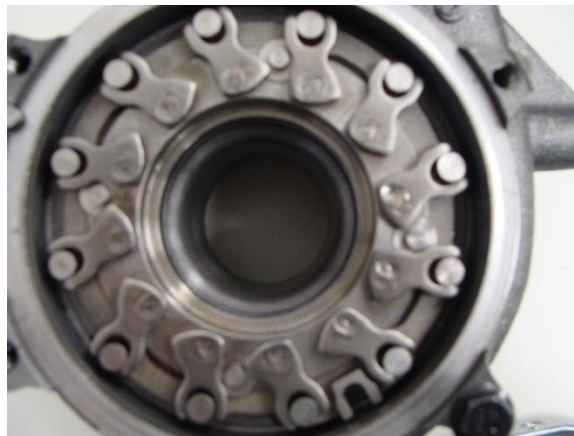
The VG levers have not been welded correctly, we have found multiple holes and imperfections throughout more than one lever.

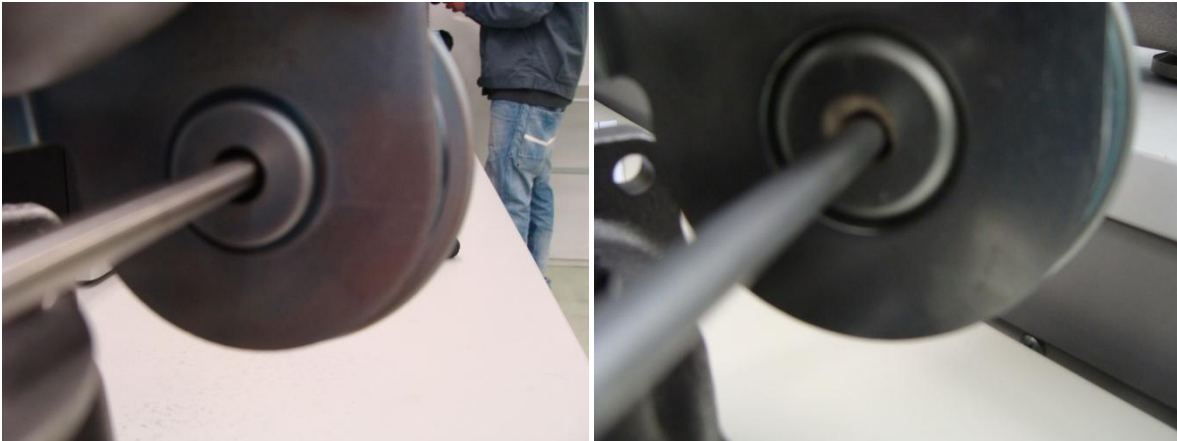
When tested we found that the actuator lever/pin is not in the correct center of the counterfeit. As seen in the pictures you can clearly see the difference of a perfectly centered actuator against a poorly fitted one. This will result in poor actuator movement and could eventually come to a failure.

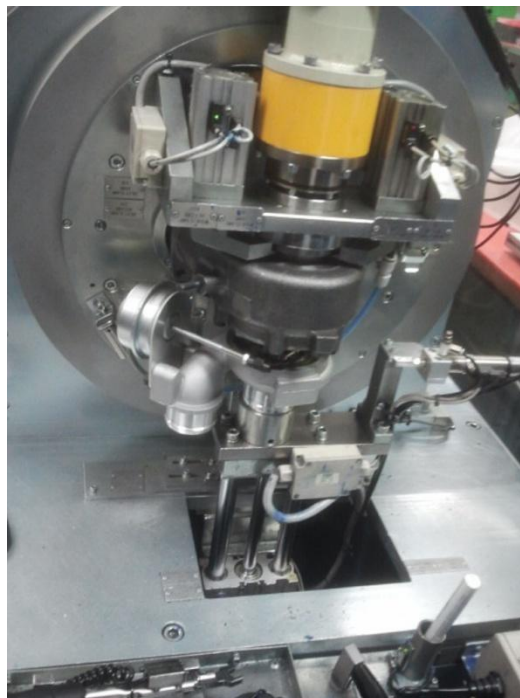
On the counterfeit LT3 turbo, the actuator has not been configured to the correct starting point. It will also not completely open or close with the corresponding pressures. In the worst case this will result in a far too high pressure with all kinds of problems and engine failures as result. The wear and damages that will occur will always be of high costs and labor.

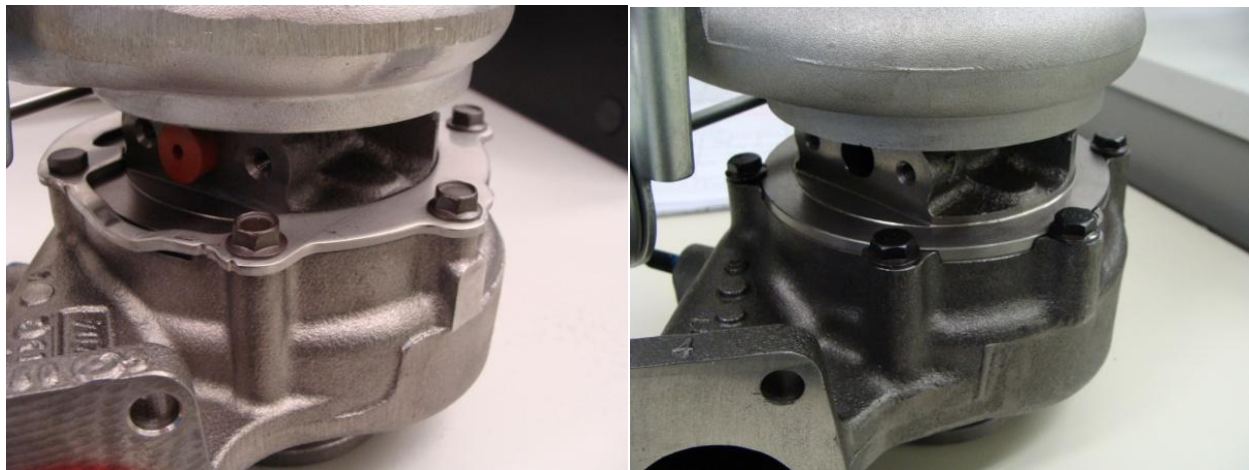
As you can clearly see on the pictures, is that the counterfeit turbo has a back plate of poor design and is mounted not correct. The bolts only hold the back plate from a fraction of its capacity. This is the old and first design of MHI that was discontinued early in the product life cycle. Keep this in mind when you receive one of these old MHI turbo`s for remanufacturing.

We also noticed that the bolts where mounted very poorly with minimal torque. MHI engineers where able to loosen the bolts by hand. MHI bolts are fitted with a torque of 8N/M. We think this lack of torque is to reduce pressure on the the low quality seal ring. Because the low quality seal ring is not capable of handling the full loads it should. The solution was found in low or hardly fastened bolts, these will balance the force that the seal ring can't. In time this will result all kind of failures or loss of power.
