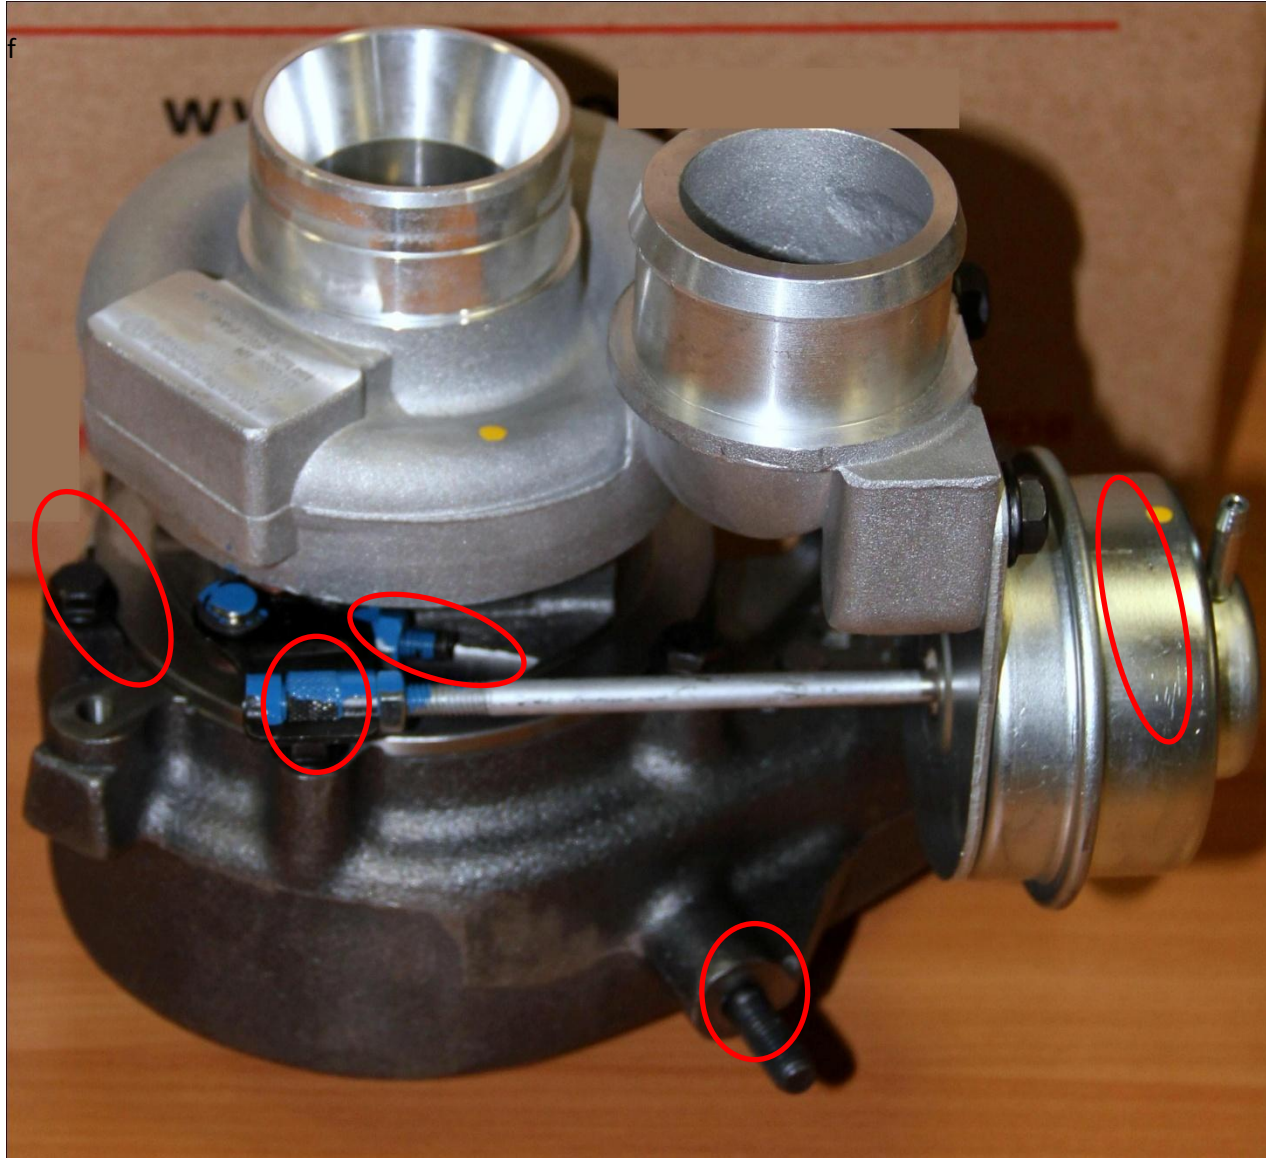
Copy LT3 T/C

- 1) Lockplates missing
- 2) Stopperbold different
- 3) No label on actuator
- 4) No paint on stud
- 5) Different structure of wheel

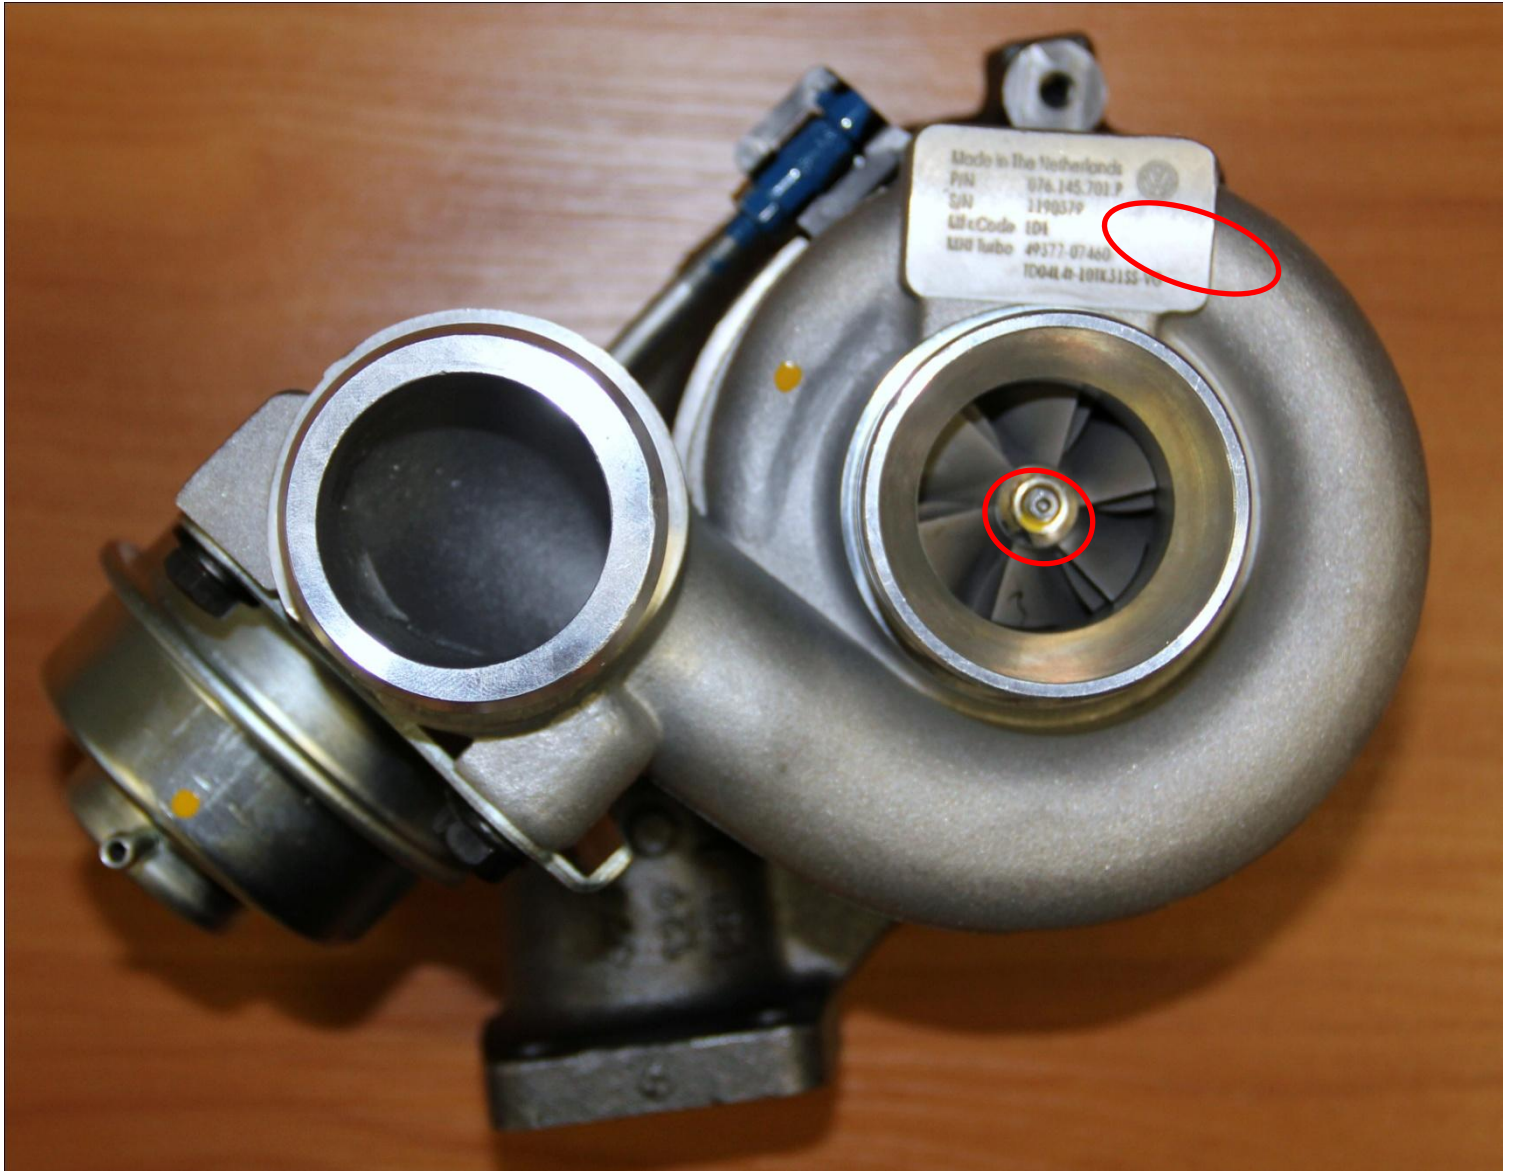
Copy LT3 T/C

- 1) Different nut
- 2) No paint on ID plate
